**Re: Dominion – Possum Point Power Station, Permit #VA0002071**

## RECON INSPECTION REPORT

<b>FACILITY NAME:</b> Dominion Possum Point Power Station	<b>INSPECTION DATE:</b> May 13, 2015	
	<b>INSPECTOR</b> Amy Dooley	
<b>PERMIT No.:</b> VA0002071	<b>REPORT DATE:</b> June 3, 2015	
<b>TYPE OF FACILITY:</b> <input type="checkbox"/> Municipal <input checked="" type="checkbox"/> Major <input checked="" type="checkbox"/> Industrial <input type="checkbox"/> Minor <input type="checkbox"/> Federal <input type="checkbox"/> Small Minor <input type="checkbox"/> HP <input type="checkbox"/> LP	<b>TIME OF INSPECTION:</b>	1300 Arrival 1600 Departure
	<b>TOTAL TIME SPENT</b>	16hrs
<b>PHOTOGRAPHS:</b> <input checked="" type="checkbox"/> Yes <input type="checkbox"/> No	<b>UNANNOUNCED INSPECTION?</b> <input checked="" type="checkbox"/> Yes <input type="checkbox"/> No	
<b>REVIEWED BY / Date:</b>

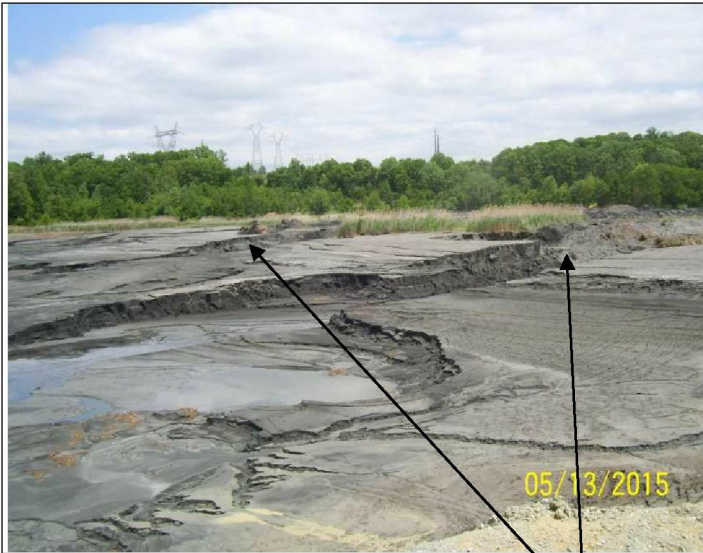
Ash Pond E was observed to have been dewatered, vegetation stripped from the top layer (approximately 8-10 inches), and dewatering channels cut into the ash. (Photo 1)

Photo 1: Dewatered Ash Pond E with dewatering trenches.

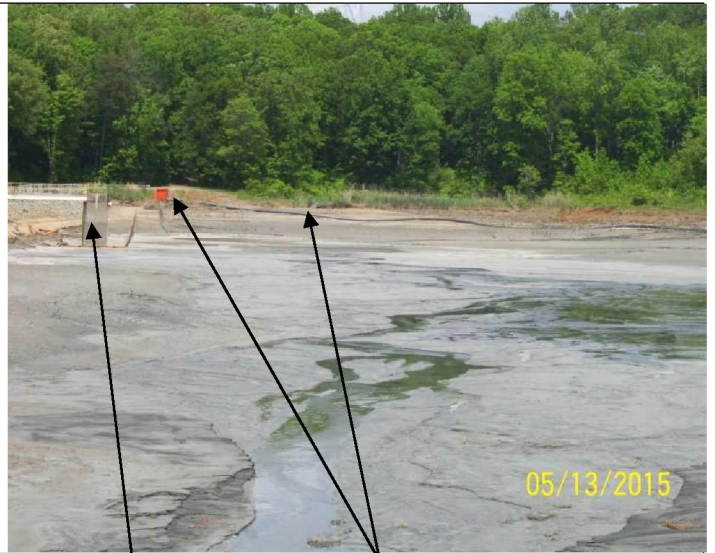
Dewatering activities were carried out via a pump on a floating intake within Ash Pond E, which pumps water into Ash Pond D. A pump in the outfall box associated with Outfall 005 pumps any discharging water back into Ash Pond E. As a result, a discharge out of Pond E has not occurred since May 7, 2015. (Photos 2-6)

Photo 2: Riser structure and pumping infrastructure to pump water from Ash Pond E to Ash Pond D.

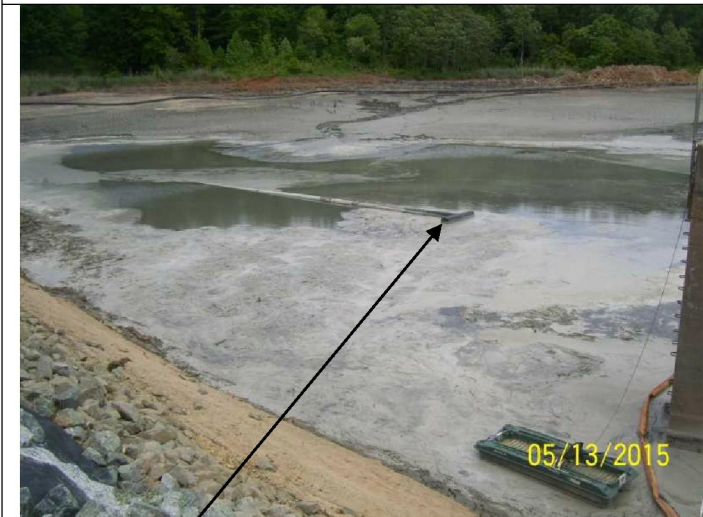
Photo 3: Floating intake on pump.

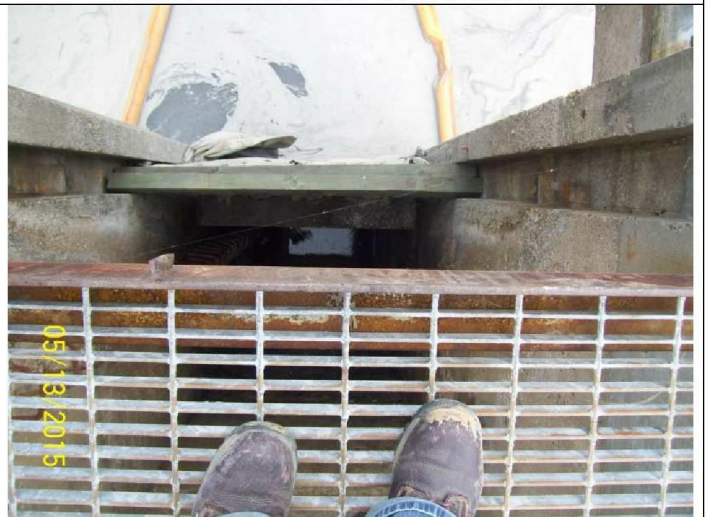
Photo 4: Inside Ash Pond E riser structure.

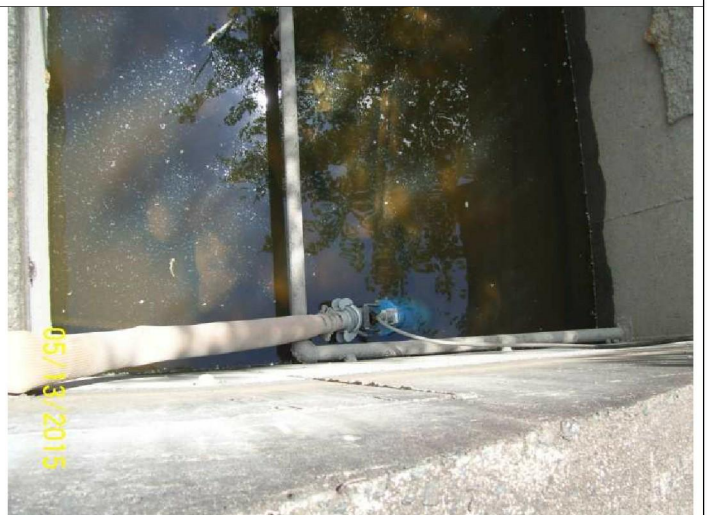
Photo 6: Submersed intake pipe to pump water from Outfall 005 box back into Ash Pond E.

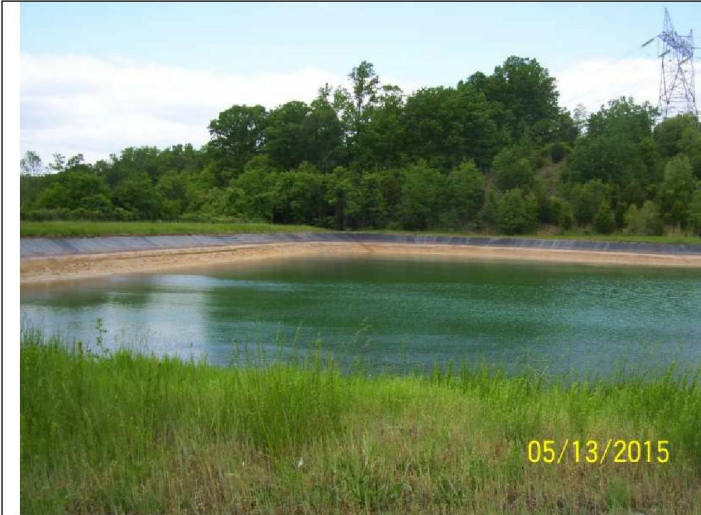
The metals cleaning waste treatment basin (metals ponds) was observed. The metals-ponds had been pumped into Ash Pond E to the maximum extent practicable and considered "empty" by Dominion. (Photos 7)

**Photo 7: Metal cleaning pond.**

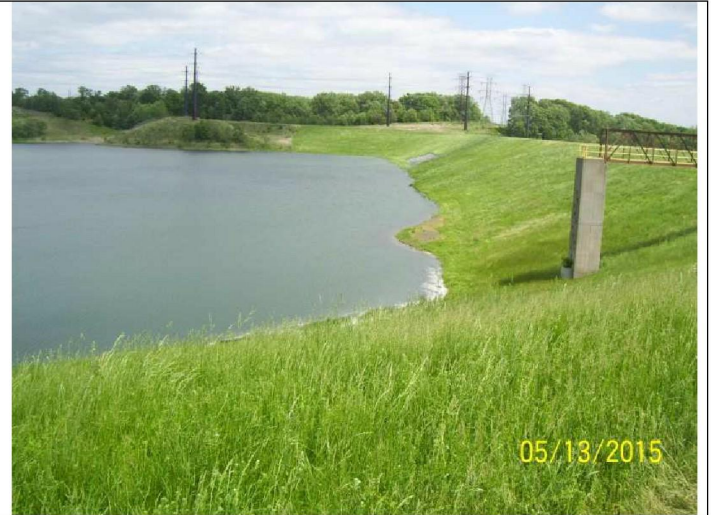
Water level observed in Ash Pond D was lower than the riser structure and piping infrastructure associated with dewatering activities in Ash Pond E were observed. (Photos 8 and 9)

**Photo 8: Ash Pond D and riser structure.**

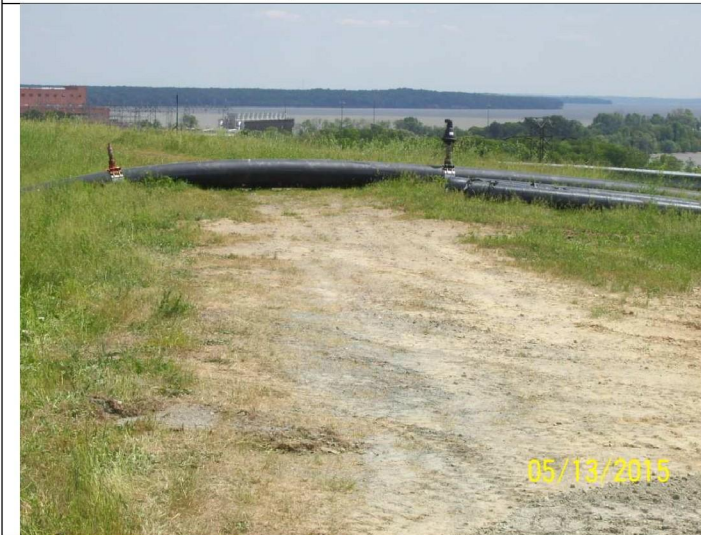
**Photo 9: Piping from dewatering activities in Ash Pond E.**

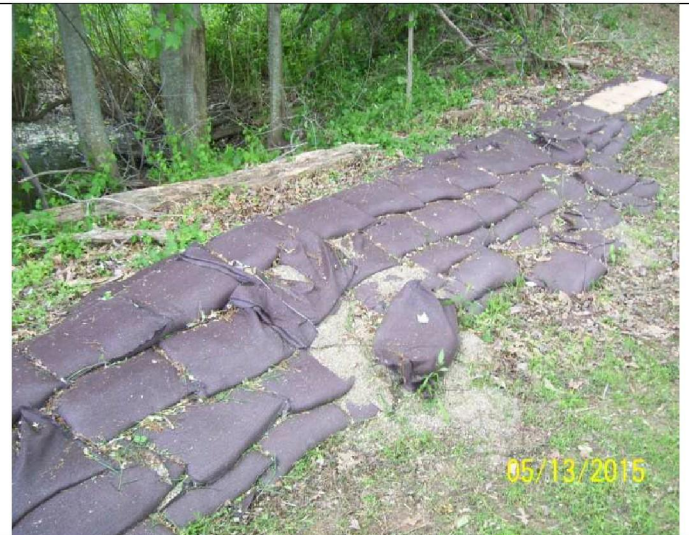
Ash Ponds A, B and C were observed. Dominion has sealed the discharge structure at Ash Pond C with a polyurethane grout in an attempt to reduce/eliminate the discharge from the structure. Additionally, sand bags have been placed along points of the berm/dam along Ash Ponds A and B to address overtopping of the berm. According to Dominion, seepage at Ash Pond A is influenced by standing water and heavy rain events. Toe seepage was observed along two points of the berm of Ash Pond B. A small amount of water was observed in Ash Pond C's discharge structure. (Photos 10-15)

**Photo 10: Sand bags installed along previously observed overtopping in Ash Pond A.**

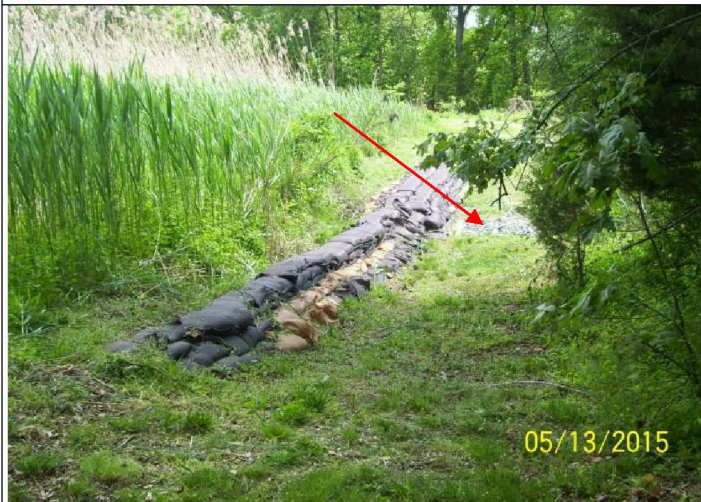
**Photo 11: Sand bags installed along previously observed overtopping along Ash Pond A and gravel installed at previous beach (red arrow).**

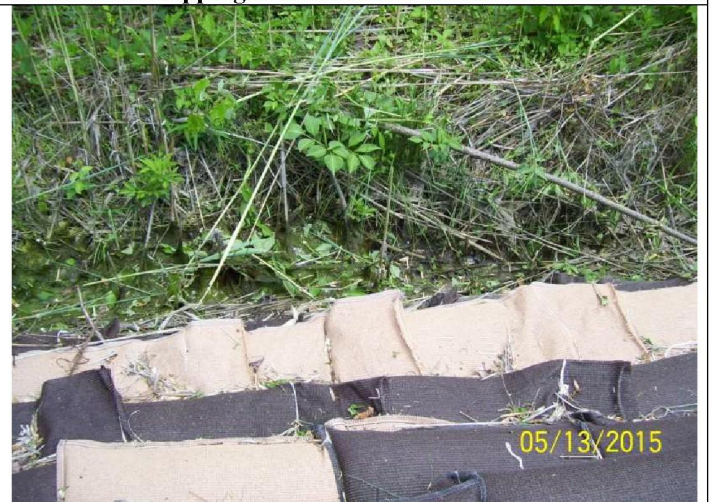
**Photo 12: Sand bags installed along previously observed overtopping along Ash Pond A. Standing water evident behind bags.**

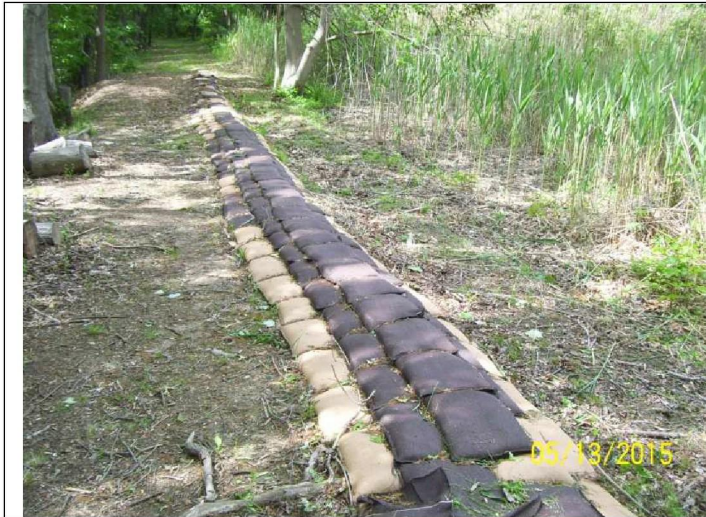
**Photo 13: Sand bags installed along previously observed overtopping along Ash Pond A.**

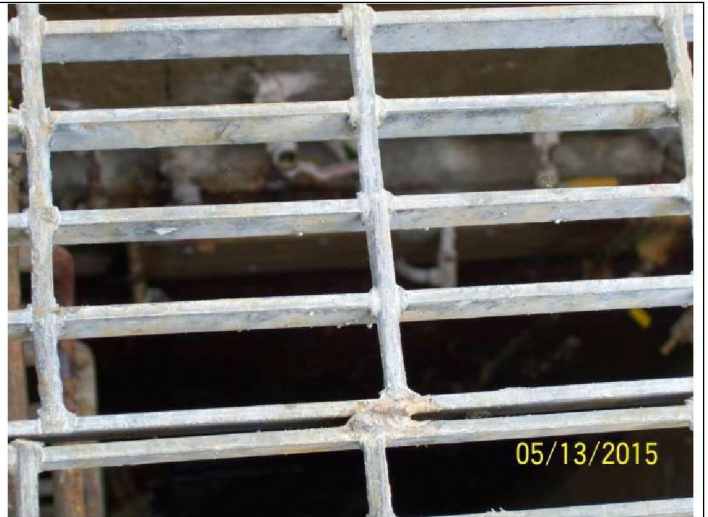
**Photo 14: Sealing of discharge structure in Ash Pond C.**

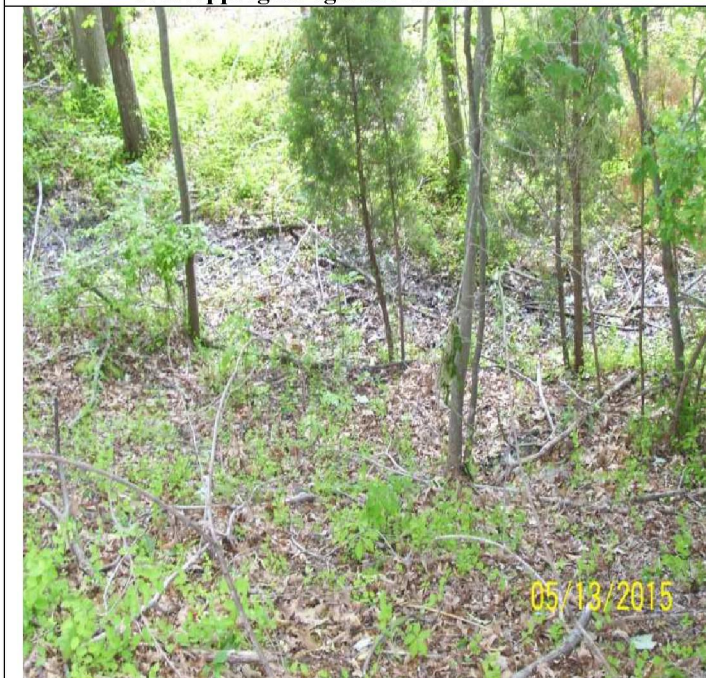
**Photo 15: Toe seepage along Ash Pond B's berm.**

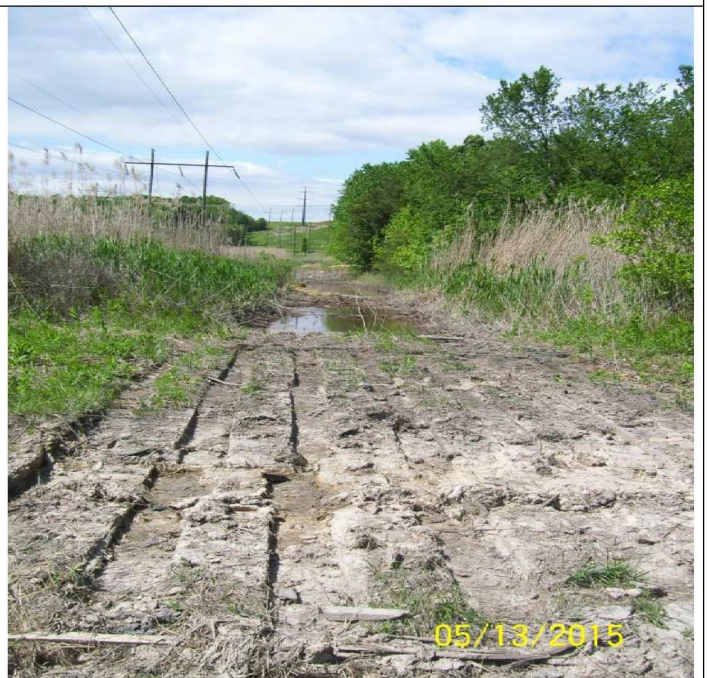
Test pits were observed along Ponds A, B, and C to determine the depth and location of ash in the ponds. (Photo 16)

**Photo 16: Test pits at Ash Ponds A, B, and C to determine extent of ash depth.**
